# Compliance inspection report form

## Existing Subsurface Sewage Treatment System (SSTS)

Property address: 14133 GLOBSTAD BEACH RD, LAKE PARK MN 56554

Brief system description: 1,000 gallon septic tank gravity to chamber trenches

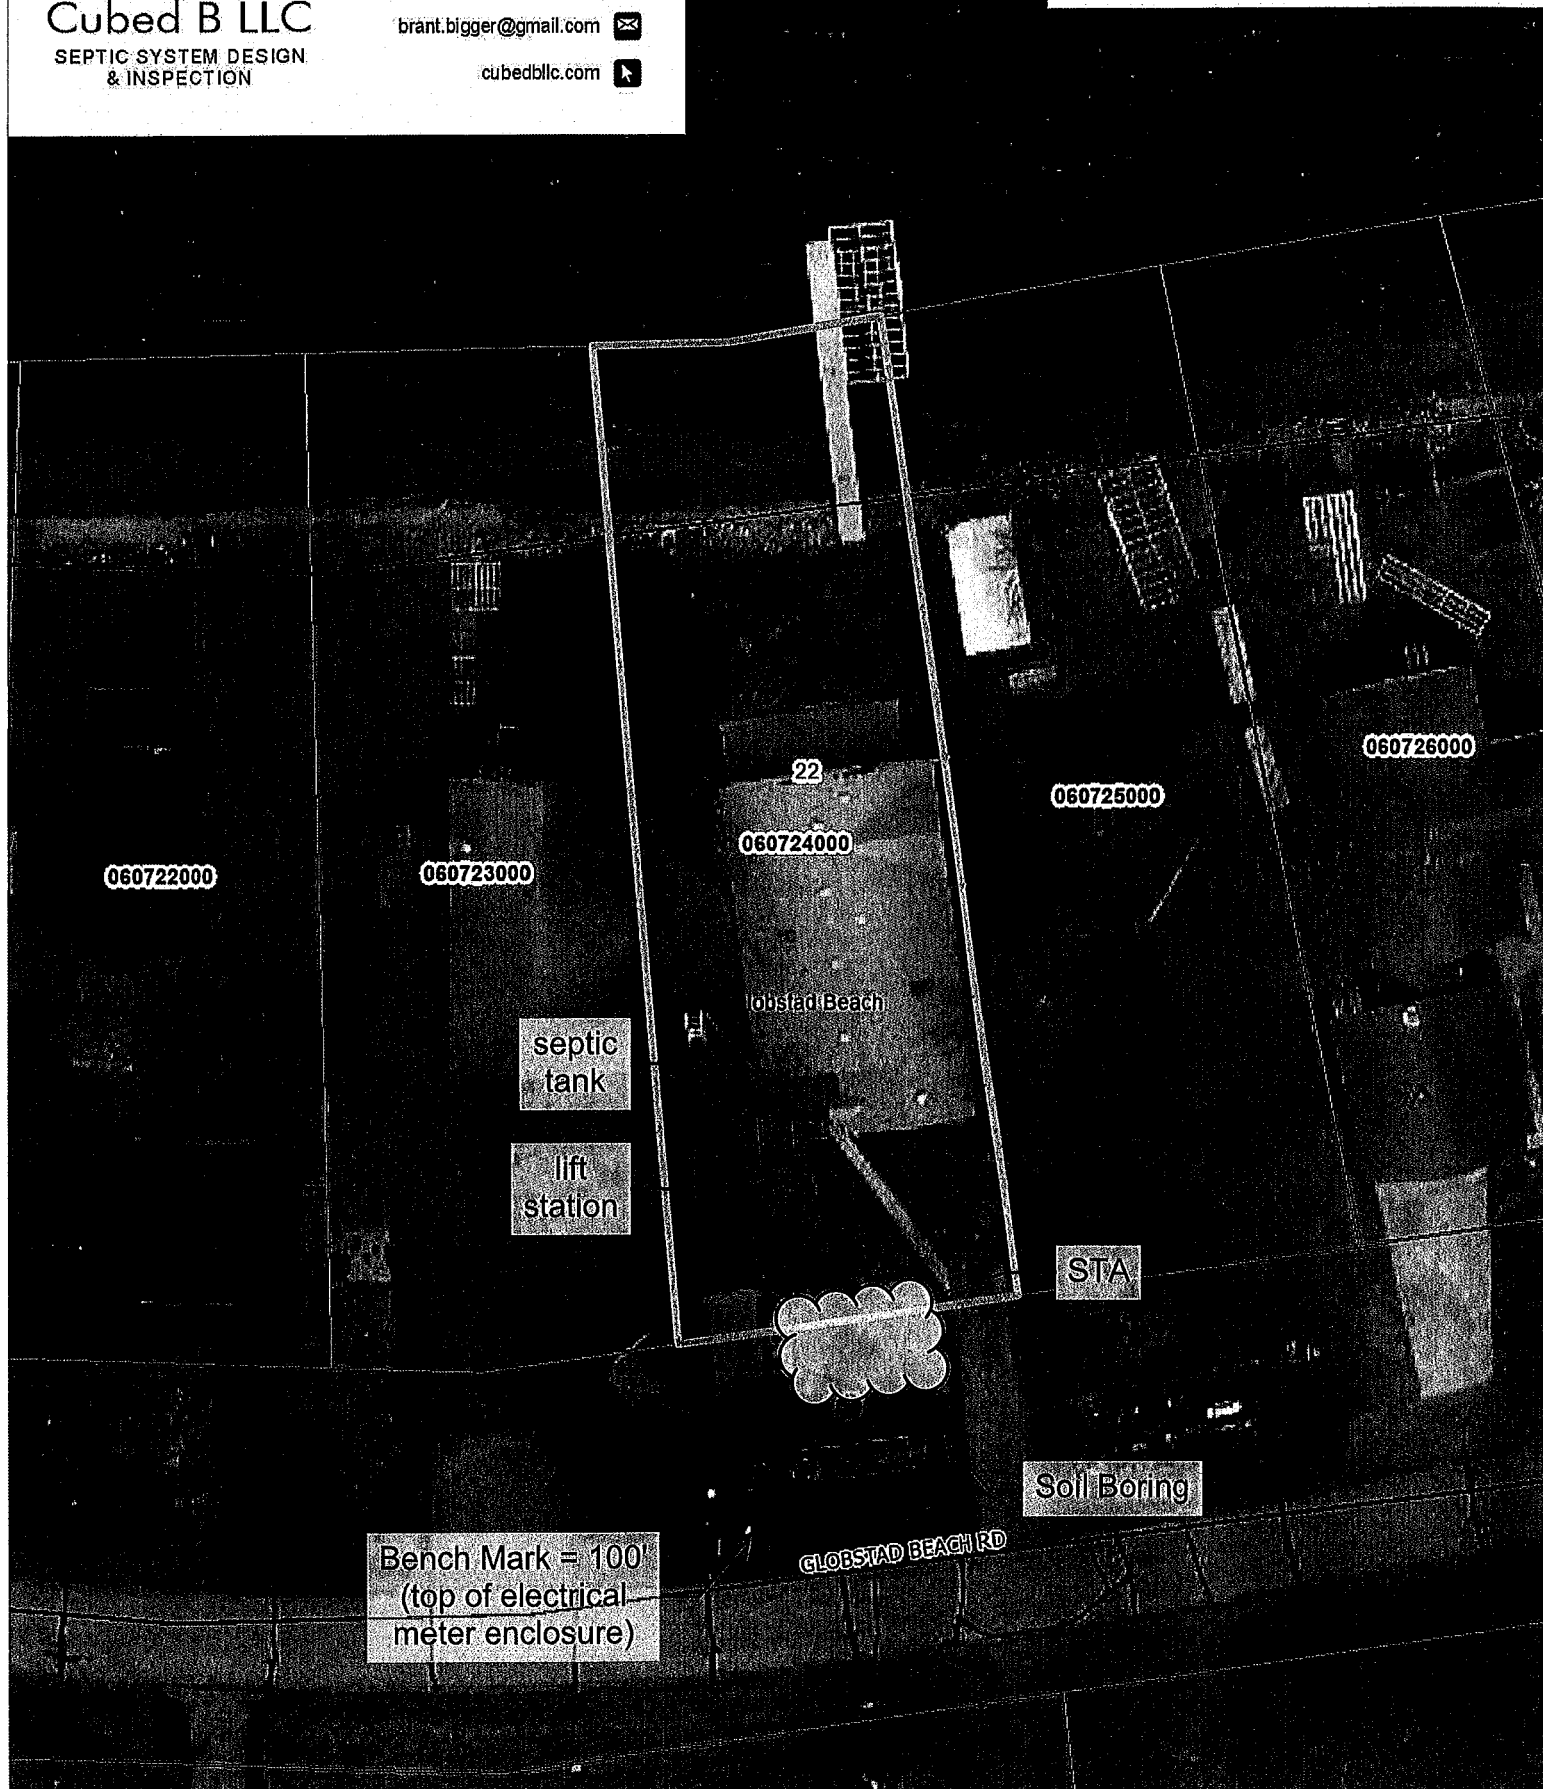
David Calderwood  
060724000  
12 Jul 2024

septic tank

lift station

STA

Bench Mark = 100  
(top of electrical  
meter enclosure)

Soil Boring

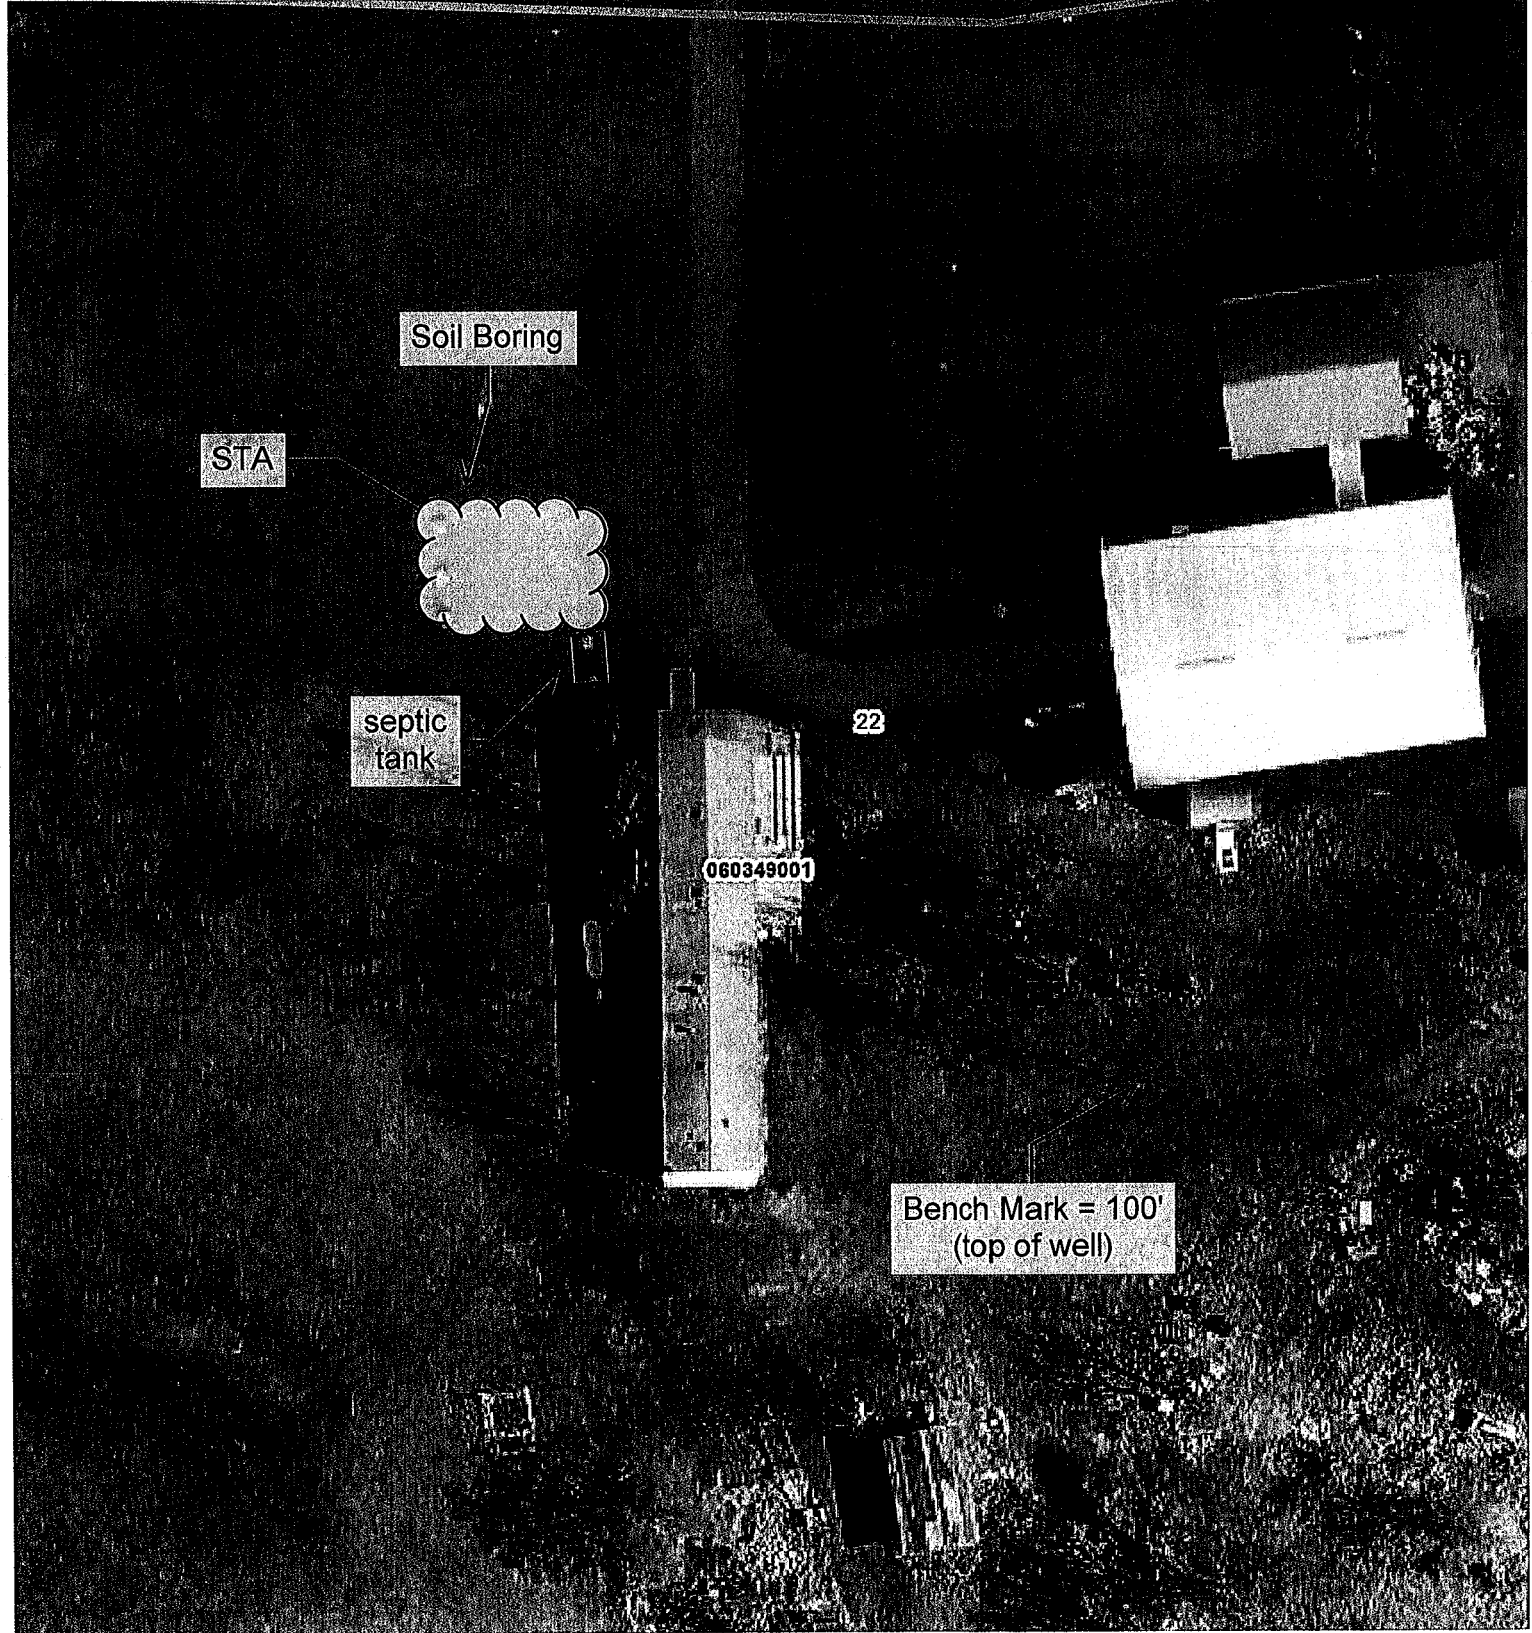
David Calderwood  
060349001  
12 Jul 2024

Conducted a soil boring (elevation 88' 6"). Redoximorphic features were not found through 50" depth in the boring (elevation 84' 4")

Benchmark elevation (100') is located at top of the well that is SW of the system.
