Certificate of Compliance

Inspection Report - Permit #: SS2024-2099

Compliance inspection report form

Existing Subsurface Sewage Treatment System (SSTS)

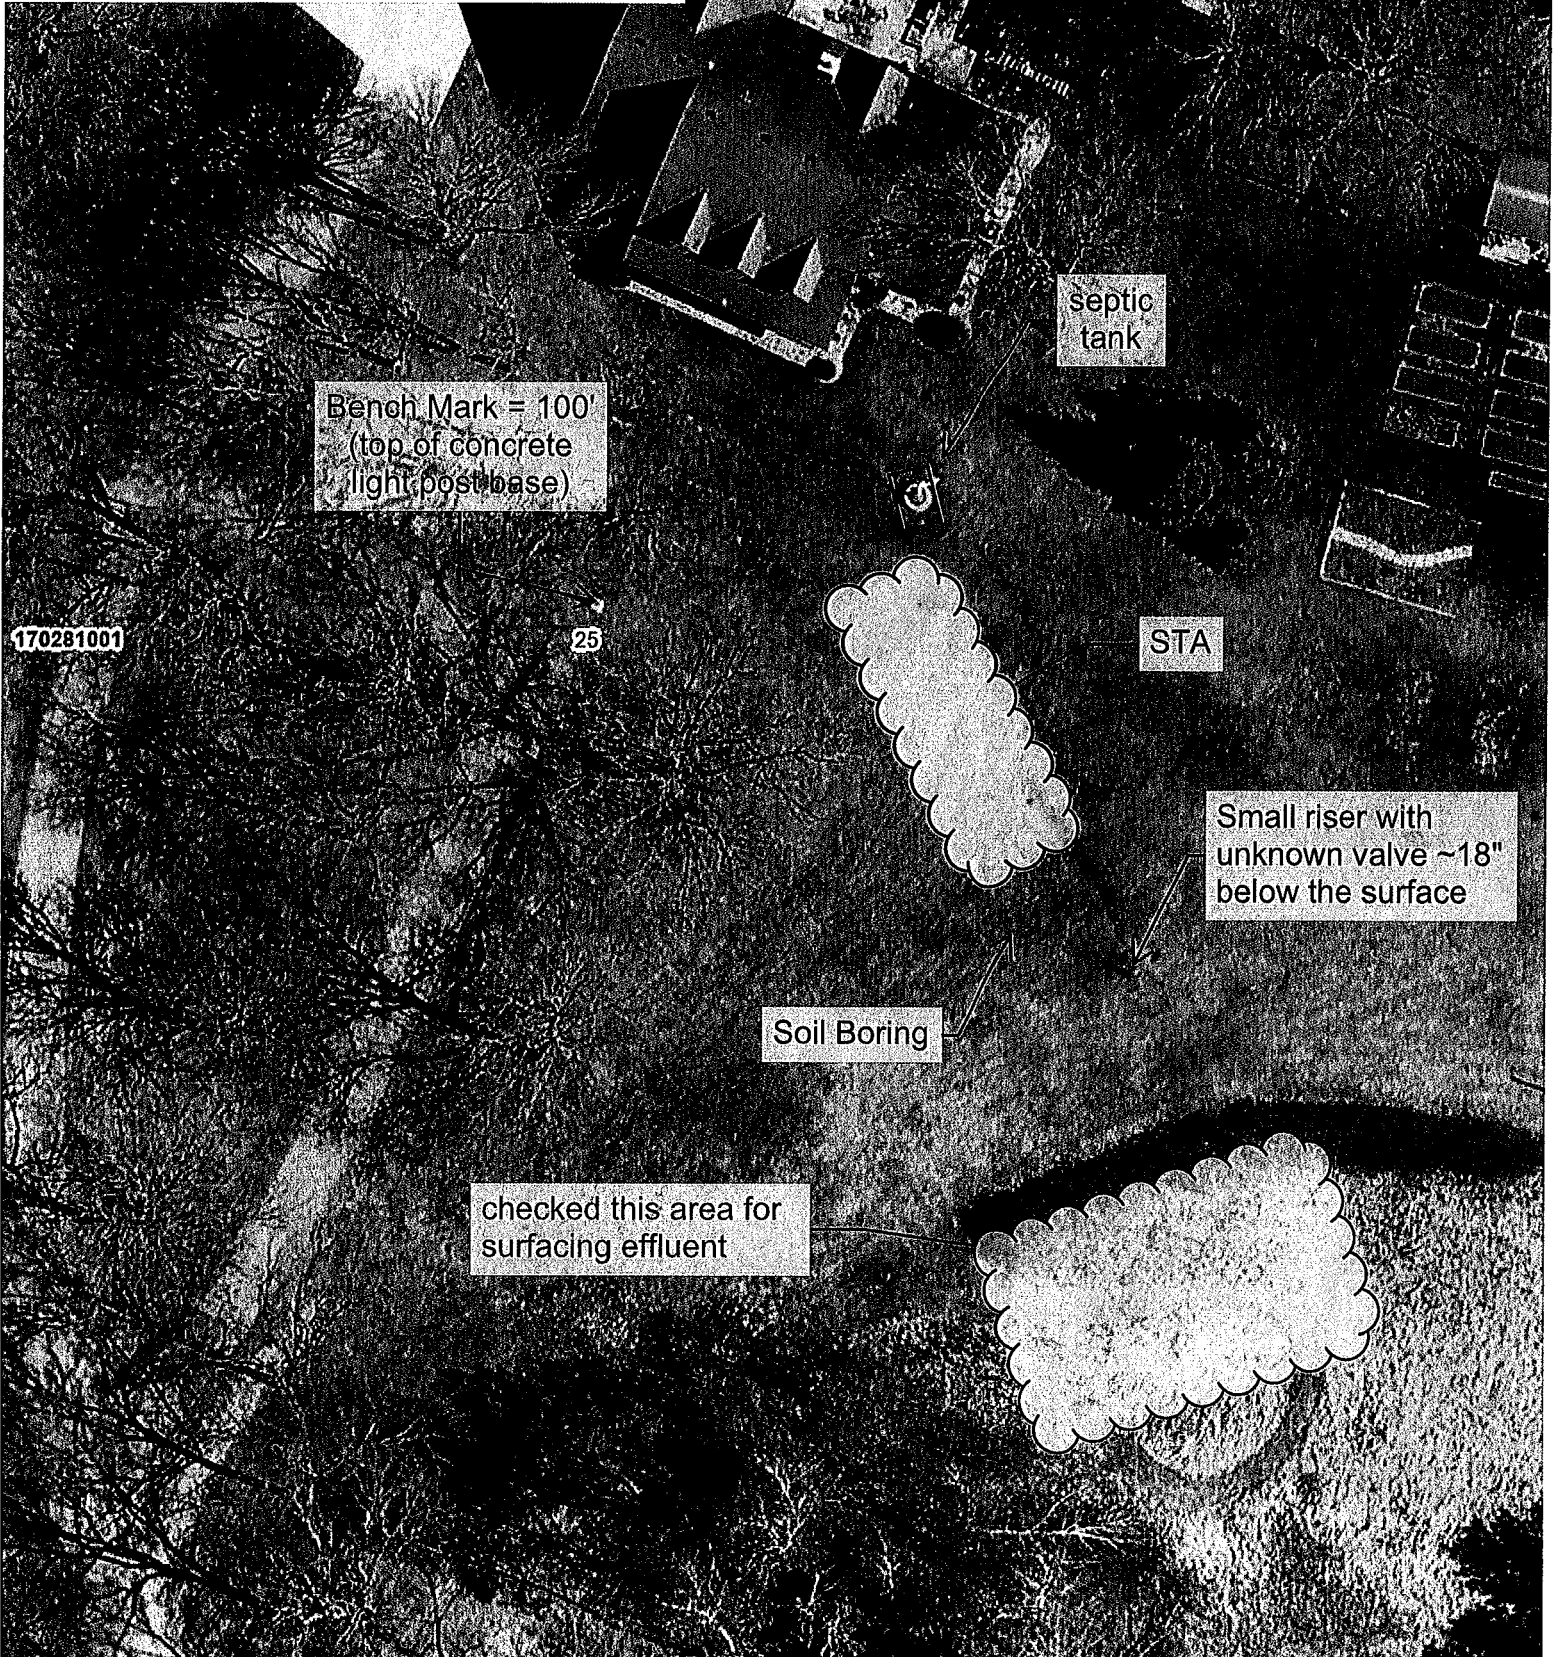
Scale: 1" = 32'

Bench Mark = 100'
(top of concrete
light post base)

septic
tank
