Compliance inspection report form Existing Subsurface Sewage Treatment System (SSTS)

Parcel ID# or Sec/Twp/Range: 171111000 Reason for Inspection zoning permit
Local regulatory authority info: Becker County
Property address: 13597 E BIG CORMORANT RD, AUDUBON MN 56511
Owner/representative: Brett Larson Owner's phone: 218-457-1975
Brief system description: 1500-gallon 2-compartment septic tank to graveless pipe STA with dropboxes

17111000
14 May 2024
Scale: 1" = 32'

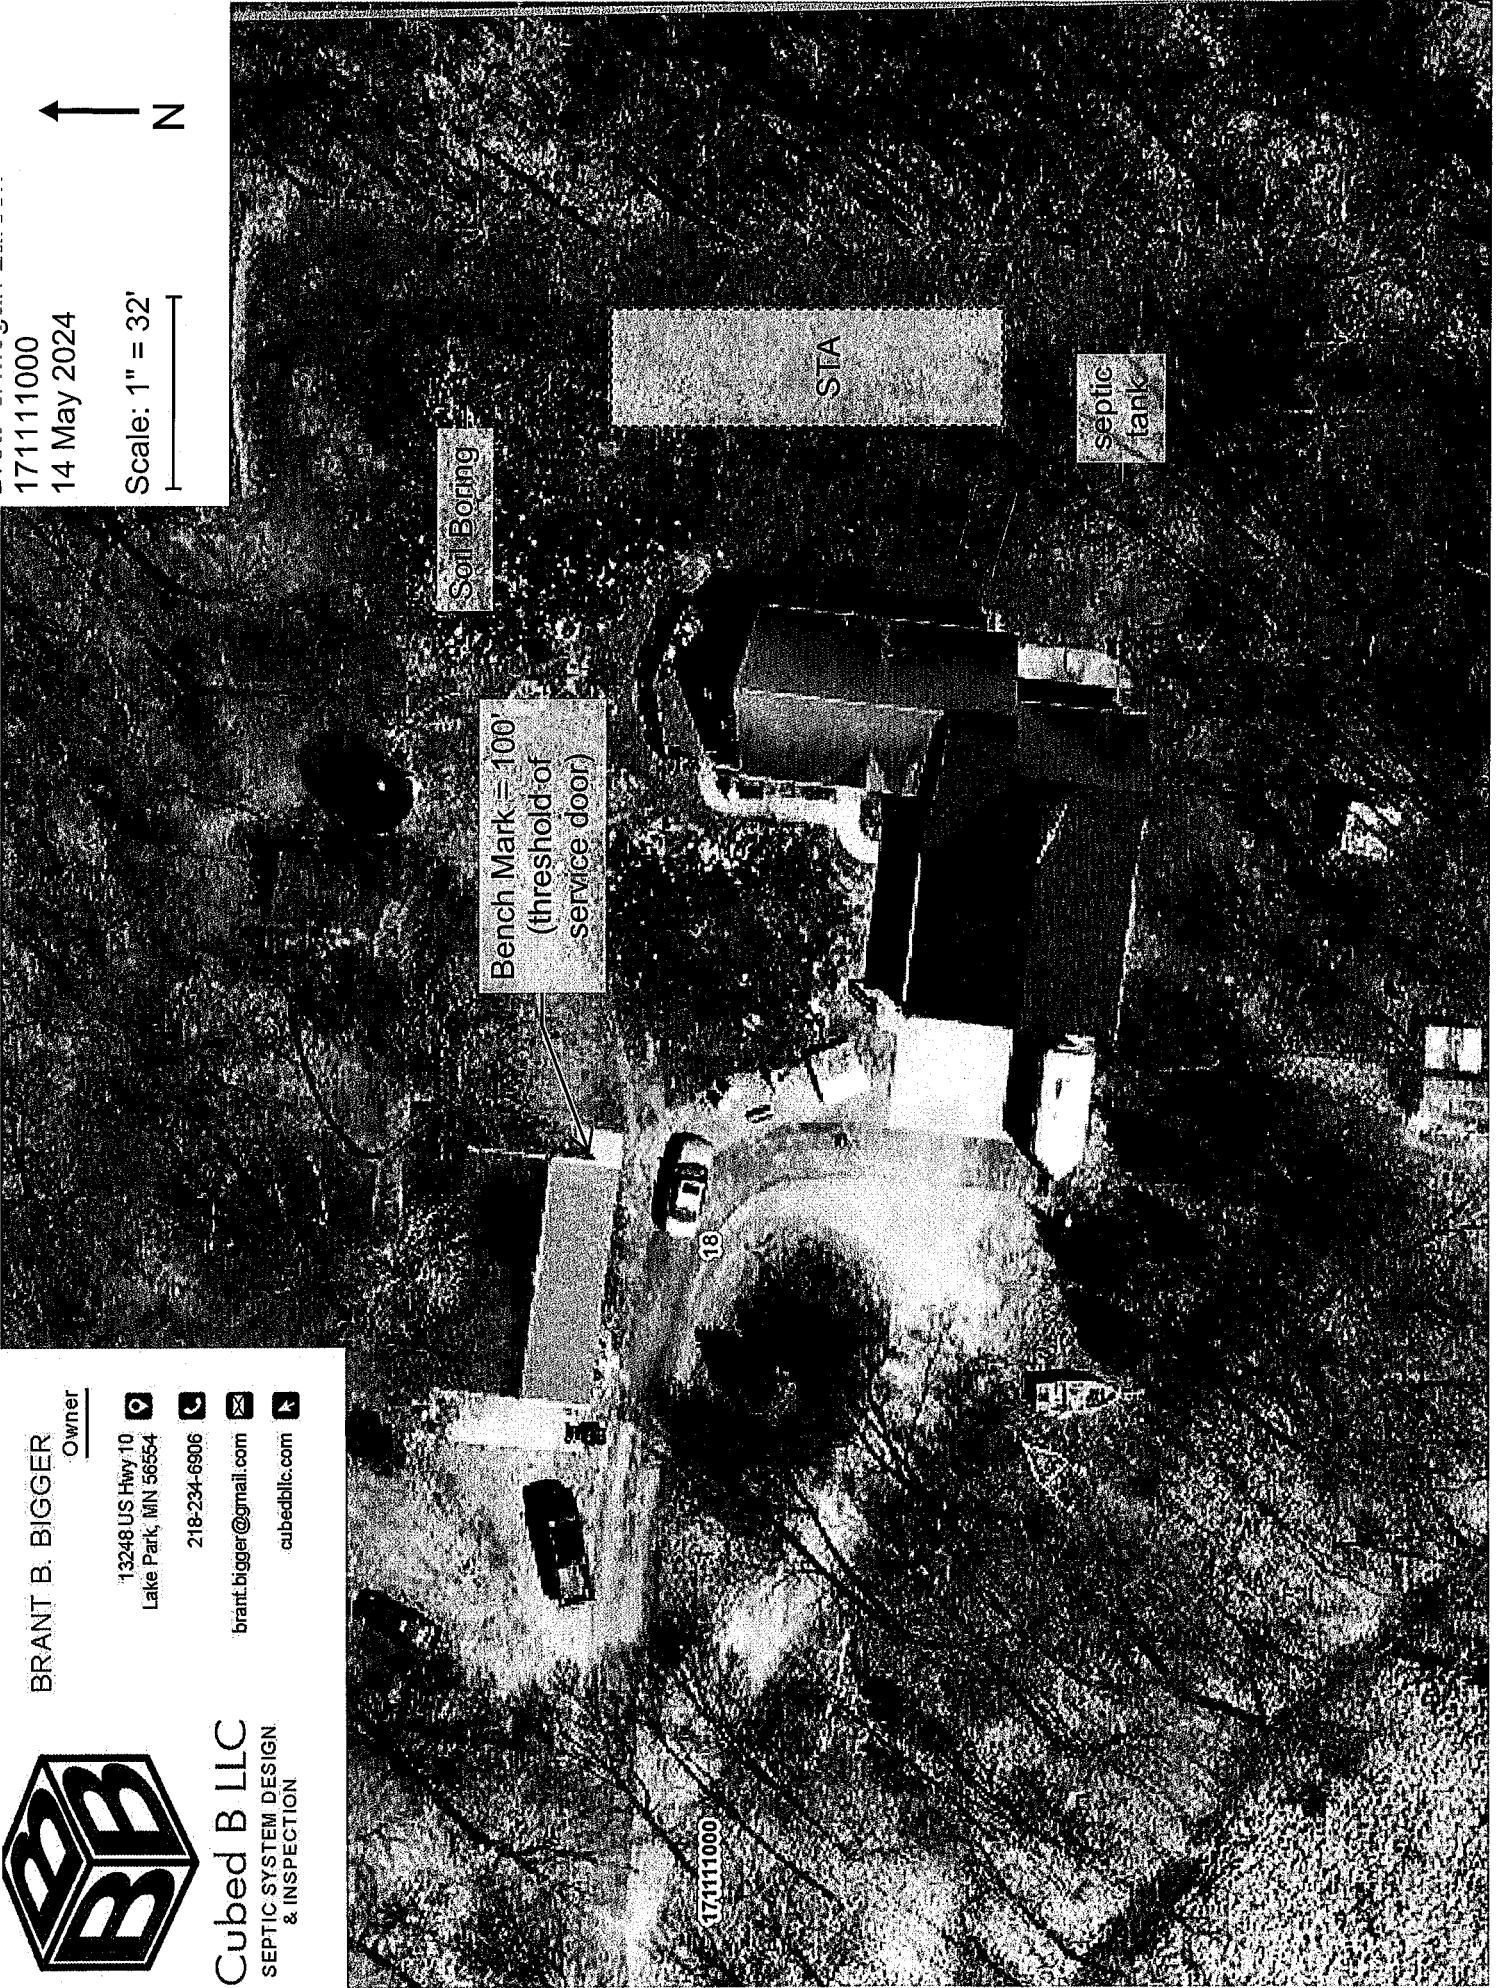
1st (western-most) lateral had 11" effluent in the inspection pipe, the 2nd lateral had 4" of effluent in the inspection pipe.

Conducted a soil boring (elevation 95' 7"). Redoximorphic features were found at 20" depth in the boring (elevation 93' 11")
 Benchmark elevation (100') is located at the threshold for the outbuilding's service door that is west of the STA.
